Archaeological Site and Reservoir Shoreline Stabilization Using Wetland Plants and Bioengineering, Rice Reservoir, Wisconsin

by Cathy J. Wendt and Hollis H. Allen

PURPOSE. This technical note describes a case study in which wetland plants and bioengineering treatments were used to protect an archeological site on an eroded reservoir shoreline and to stabilize the shoreline from further erosion. The site is called the Robinson Site and is located on Rice Reservoir in northern Wisconsin, about 26 km (16 miles) southeast of Rhinelander.

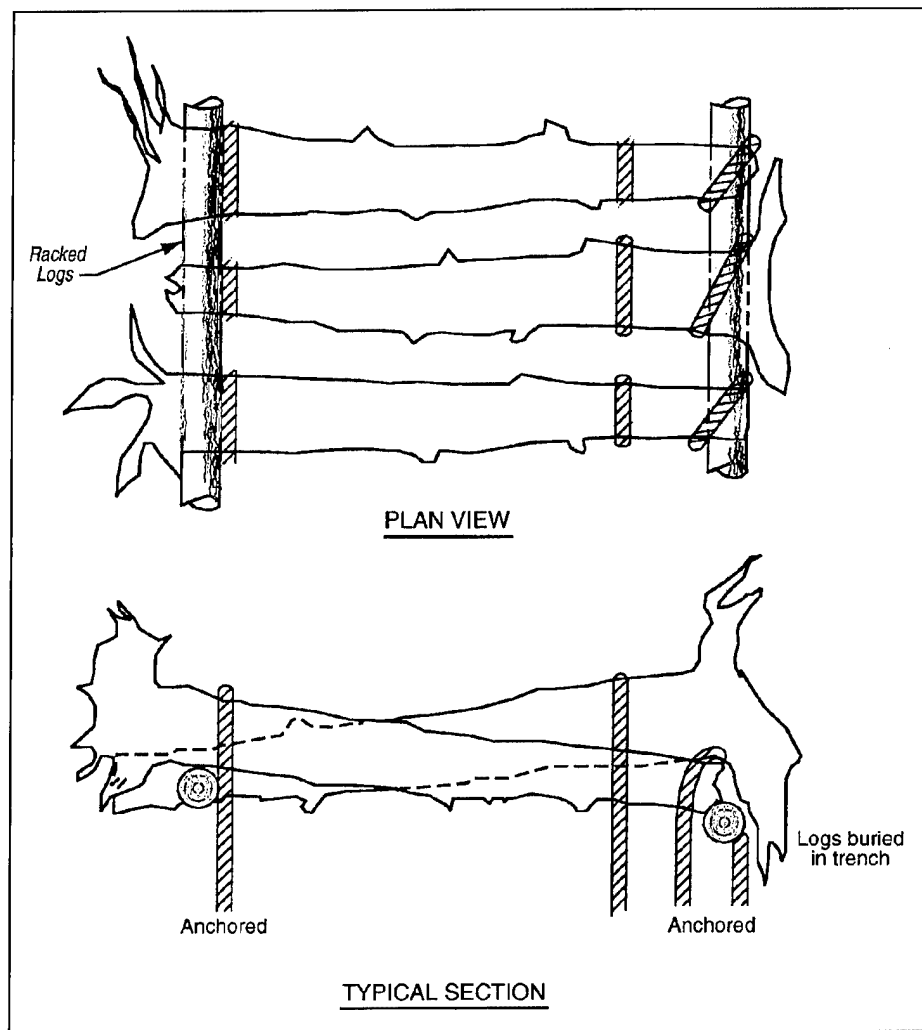
Figure 4. Anchored log wave deflector

Zone 1 Wave Deflector Performance. The wave deflectors failed within 5 months of installation. The precise cause of the failure was not documented or observed, but it appears that at a partial drawdown level, the wave action undermined the bottom crosspieces. When the water level again rose, it apparently floated the loosened crosspieces away, allowing the large trees they supported to buoy up and down with the waves, thereby loosening the anchoring system. The wave deflectors were removed entirely after the anchoring system failed.

- Wave deflectors must be installed differently in a reservoir with fluctuating water levels. Possibly if the crosspieces were eliminated from the design, the larger trees could be anchored more securely.
- Fiber rolls can be easily vegetated using willow cuttings. There does not appear to be any advantage to using rooted stock instead of dormant, unrooted cuttings. Inserting herbaceous plants into the fiber roll is difficult and was not very successful at this particular site.

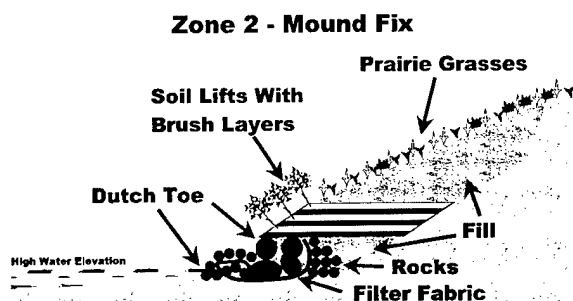
Figure 5. Mound site fix

Top Bank Treatment. Two variations were utilized. The critical area near the mound was filled above the vegetated geogrid to the top of the bank (Figure 5). The area was then hydroseeded with prairie grasses (*Elymus canadensis*, *Andropogon gerardi*, *Schizachyrium scoparium*, *Bouteloua curtipendula*, and *Sorghastrum nutans*) and covered with an Excelsior®

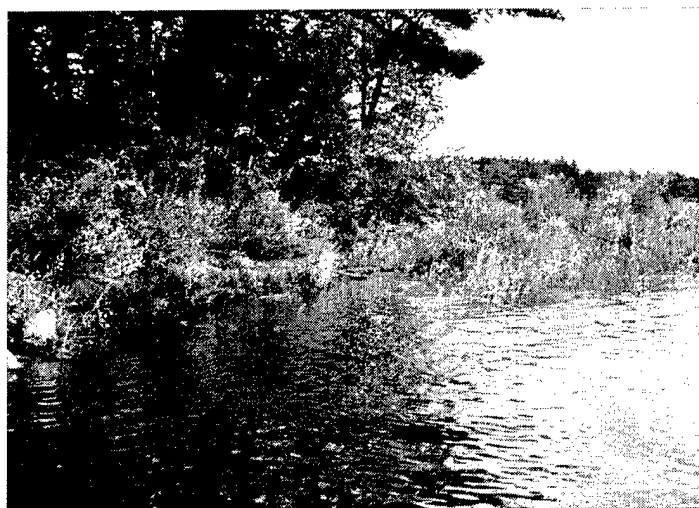
In Zone 1, the fiber rolls have remained intact (Figure 9) with an added benefit of providing wildlife habitat. Burrowing animals, primarily rabbits, excavated and inhabited small

Figure 9. Zone 1, July 7, 2000

openings behind the fiber rolls. These openings do not seem to be compromising the integrity of the structure. The rabbits browsed much of the willow over winter that had been planted as cuttings behind and between the fiber rolls. Despite the browsing, the willow resprouted. Of the 20 rooted willows (USFS stock) that were planted, 10 have survived.

Juncus spp. and *Scirpus* spp. planted directly in the fiber rolls suffered high mortality with only 10 percent of the original plants remaining on August 11. However, the fiber rolls are becoming vegetated by native volunteer species.

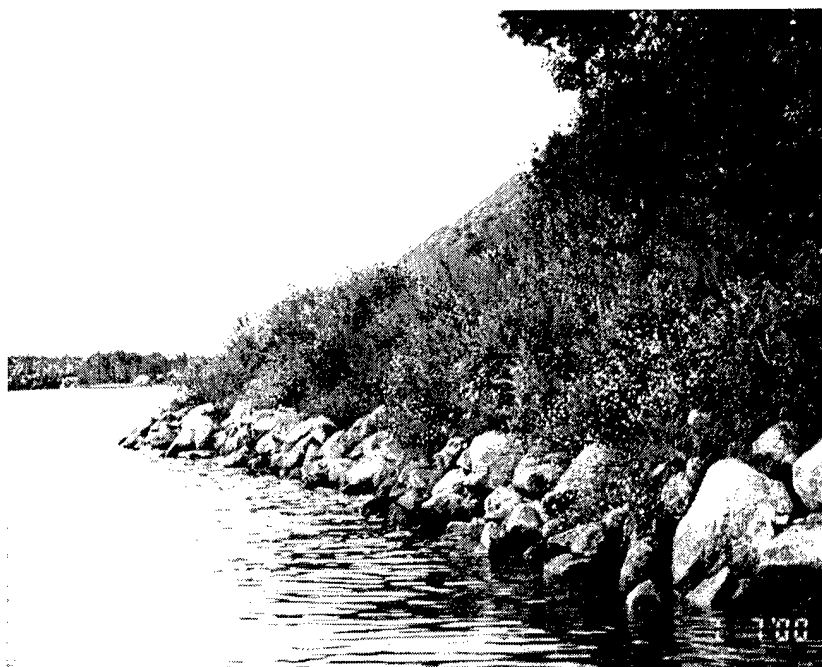
Zone 2 Rock Toe Performance. The rock toe has performed as expected for the majority of the zone (Figure 10). Soon after completion, however, the reservoir level rose and a void was created behind the large rocks, causing 1.5 lin m (5 lin ft) of soil lifts to collapse. Filling this area with small rock repaired the void and no further erosion has occurred in this area.

Additional smaller areas (1-2 m³ or 11-22 ft² each) have also washed out, but no major problems seem to have been created by these voids. As a preventative measure, these new voids could be filled, but the voids seem to have limited themselves and our intent is to monitor them to see if they will be "self-healing." All of the voids are located away from the mound. It appears that the reduced level of armoring in the fix away from the mound may be contributing to these minor failures. No failures have occurred in the mound fix area.

Figure 10. Zone 2, July 7, 2000

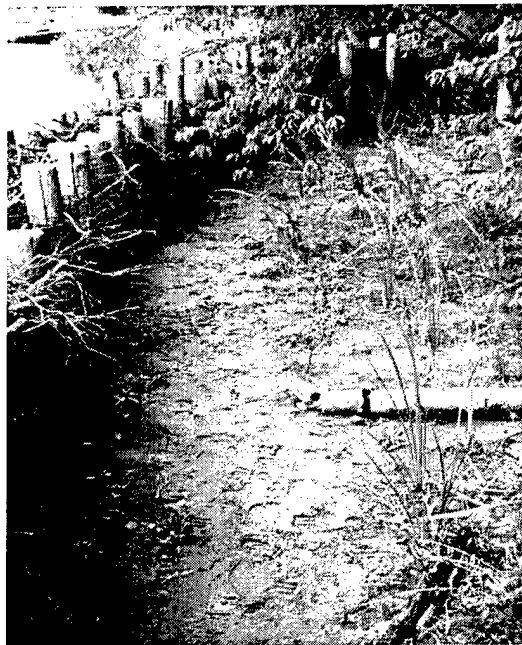
Zone 3 Branchbox Performance. The branchbox breakwater is providing limited habitat for emergent plants (Figure 14). The habitat is limited because Wisconsin laws prohibit most structures from being more than a few feet away from the shore. The Wisconsin Department of Natural Resources did, however, allow this structure for demonstration purposes, but only allowed it to extend 4.5 m (15 ft) from the shore. This is still short of the more typical placements of 10 m (33 ft) or more.

Figure 14. Area behind branchbox breakwater

It appears that the area between the branchbox and shore may have suffered from either or both of two effects created by the branchbox's proximity to the bank. First, the protected area is shaded by existing trees on the steep bank for half of the day, then is shaded by the branchbox breakwater for much of the remainder of the day. This lack of sunlight may be responsible for an observed 0.76-m- (2-1/2-ft-) wide area directly behind the branchbox that is unvegetated (Figure 14). Second, sand has deposited behind the branchbox to a height approximately 6 in. higher than directly in front of the branchbox. This sand appeared to be enough to cover small plants as they began to grow. Between this 0.76-m- (2-1/2-ft-) wide void and the original bank, however, there is vegetation. Quadrats were used twice to assess the vegetation of the entire area behind the branchbox breakwater, once on May 17, 2000 and again on July 7, 2000. The entire area was covered with 28 quadrats or partial quadrats. Numbers of *Juncus effusus*, *Scirpus spp.*,

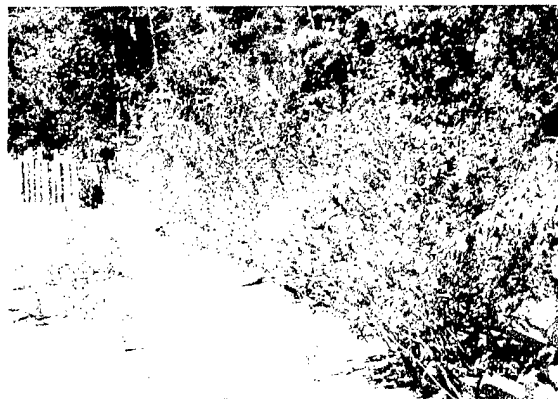
Zone 3 A-Jacks® Performance. Due to the heavy vegetation, the A-Jacks® are barely visible from the water. Although the total stem count has decreased (359 stems on July 7, 2000 down from 391 stems on May 16, 2000), the percent area covered is increasing based on visual comparison of photos (Figures 16 and 17). The stem count may have decreased for several possible reasons. First, the water level of the reservoir was within 3 ft of full by the middle of April, which provided the plants with adequate moisture producing the initial surge of growth indicated by the high stem count for May. Second, from the end of June through early August the water level was within 1 ft of full and some of the individuals may have succumbed to drowning and/or wave action causing abrasion from the A-Jacks®, lowering the overall stem count. Third, competition for light and nutrients between individual plants may have been a source of mortality.

Figure 17. A-Jacks® willow coverage, July 2000
